TITLE **Problems with ISDN after inserting ADSL splitters**

PROJECTS ADSL (splitters), SpM (line sharing)

ABSTRACT This TD reports over problems experienced with the ISDN service after inserting splitters for "ADSL over ISDN" on existing ISDN lines. Both, splitters and ISDN line equipment (LT and NT1), are expected to be compliant with European standards, however an interworking problem is observed. The result is that the NT1 will not start-up.

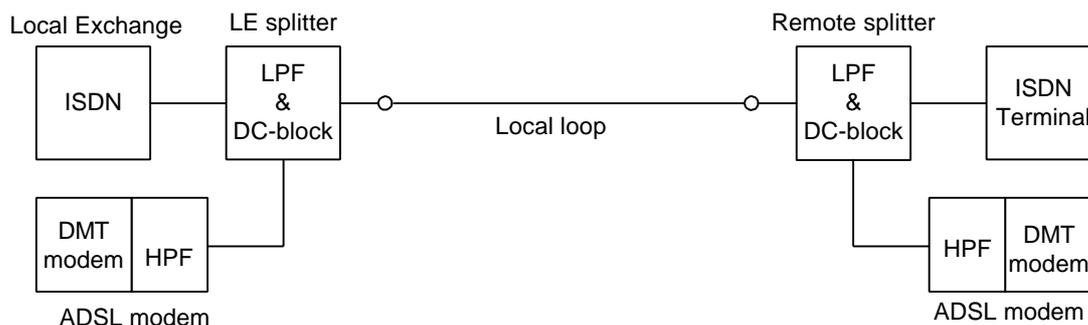
Figure 2: ISDN line with splitters (and ADSL modems)

An ISDN line without and with splitters is depicted in figure 1 and 2.

The cause of the problem could be that the splitters may be not transparent enough for this first generation NT1, or the NT1 is not able to accommodate the new properties of the loop, caused by the splitter(s). The splitters, which were installed, are optimised for impedances of 135 Ω and 150 Ω .
